Manhole Inspection Summary

Manhole # S13CC_002MH

Location Address: **2900 RIGGS AVE**

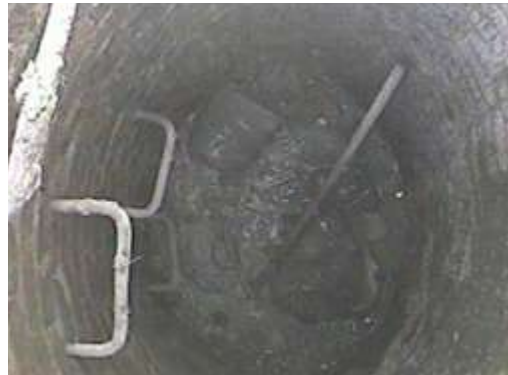
Defect 2

Chimney / Frame Adjustment ☒ Exists Material: **Brick and Concrete** ☐ Parged Height: **3** (in.)

Condition: ☐ Sound ☒ **Cracked** ☐ Root Intrusion ☐ Loose Brick ☐ Deteriorated

CRACKED FRAME ADJUSTMENT

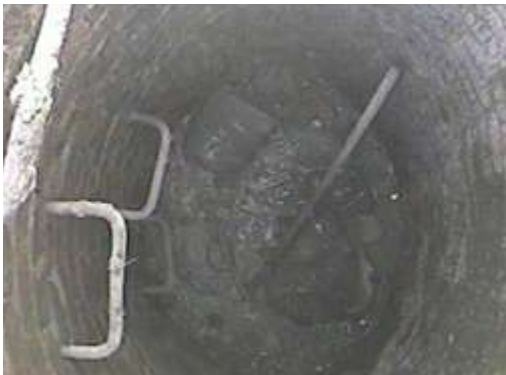
Defect 1

Condition: ☐ Sound ☐ Cracked ☐ Root Intrusion ☐ Deteriorated ☐ Leaks ☒ **Debris**

DEBRIS ON CHANNEL

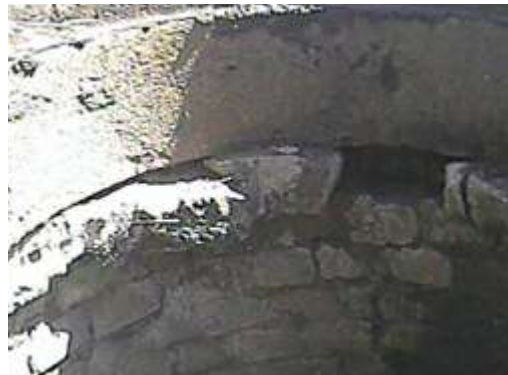
Defect 3

CRACKED FRAME ADJUSTMENT

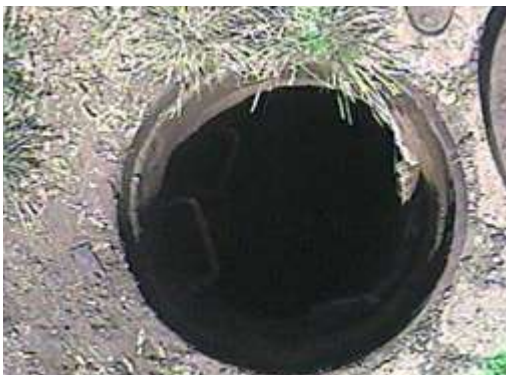
Frame Offset: **2** (in.) Condition: ☒ Sound ☐ Cracked ☐ Leaks

FRAME OFFSET

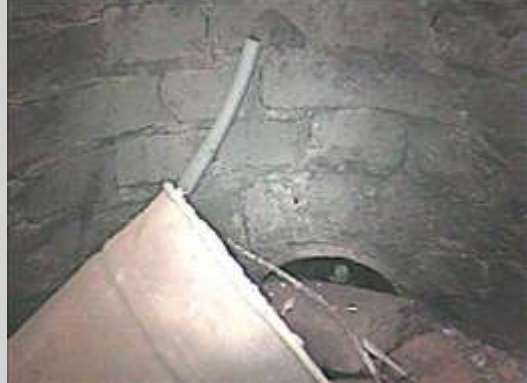
12 O'Clock Outflow

8 in. Circular Gravity Sewer
Pipe Out @ 12 O'Clock

Deposits: ☐ None ☐ Mud ☐ Sludge ☒ **Debris** ☐ Grease

Silt Depth: **3** (in.) Deposits Extent: **Medium**
